# Journal of Engineering Technology and Applied Physics

## Evaluating The Impacts of Speed Bumps on Pavement Condition

**Abstract**—Speed bumps are a common traffic calming measure used to reduce vehicle speeds and improve safety. However, installing speed bumps without adherence to recommended standards can lead to additional problems, such as increased wear and tear on both vehicles and the road surface. This study investigates the impacts of speed bumps on Pavement Condition Index (PCI), focusing on surface roughness, cracking, and rutting. For this purpose, five asphalt-paved roads in Benue State were selected, including Makurdi–Aliede, Gboko–Ugbema, Makurdi–Gboko, Vandeikya–Tsar, and SRS–JOSTUM Southcore. Each site was divided into sections, and PCI values were calculated based on various distress types such as longitudinal cracking, block cracking, and rutting. The results indicated significant pavement deterioration near the speed bumps, with PCI values dropping to 18 on the Makurdi–Aliede road and to 10 on the Gboko–Ugbema road in sections directly after the bumps. Rutting was found to be the dominant distress type, particularly in the sections closest to the bumps. Howev

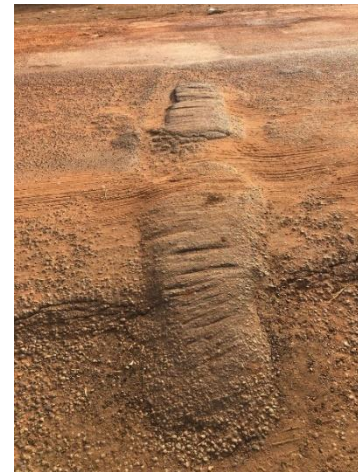
Fig. 2. A Typical speed bump on the studied road.
